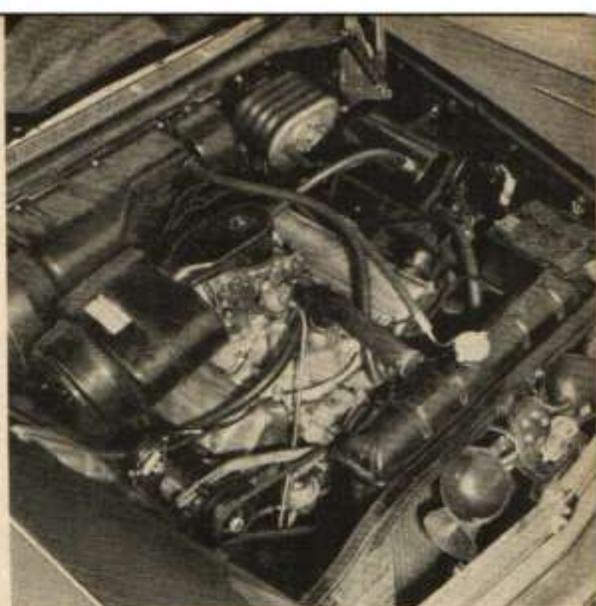
Power pack mill with host of accessories and a single four-barrel carburetor. The V8 ran best with a slight spark advance.

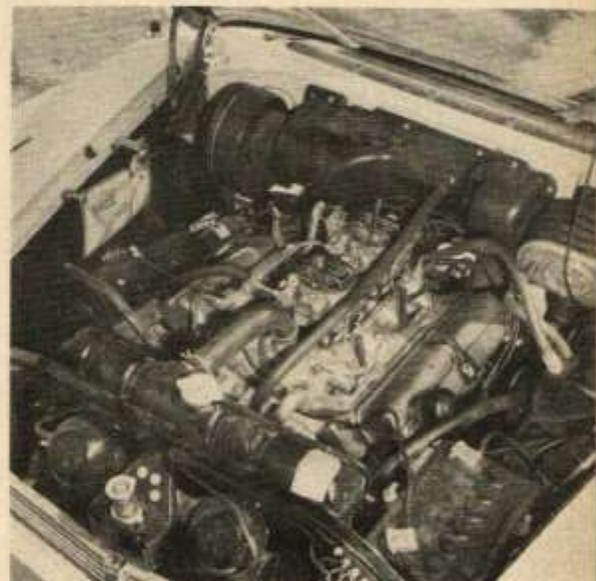
318-cubic inch Fury engine with two four-barrel Carters. Two dry-mesh air cleaners are used here and are practically silent.

The noise level in the cab is quite low at normal city and highway speeds. Above 70 mph or so, there are some shrill whistles that center themselves around the windshield posts and it doesn't seem to matter whether the windows are up or down or whether the quarter-windows are open or closed. The firewall was well-insulated from heat and most engine noises but with the standard Plymouth, there was a rather disturbing racket caused by a restriction in the air cleaner throat. On the other hand, the Fury engine was practically silent.
