OF MAINTENANCE ECONOMY AND EASE

WHAT THE CAR IS LIKE TO LIVE WITH

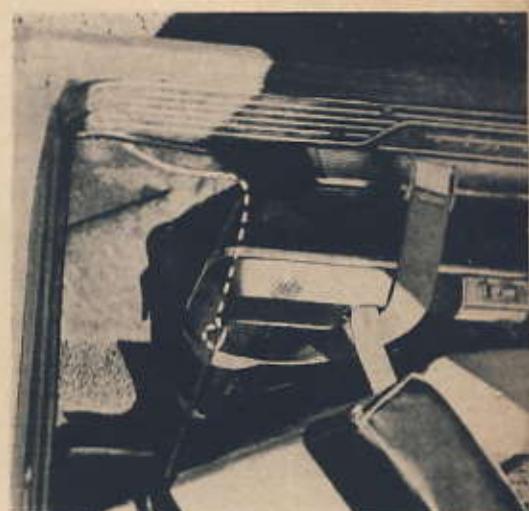
Dodge safety belts wrap around transverse bar at rear of seat. Top of seat frame is a narrower bar, encircled by a steel cable (dotted line) which goes down through seat and under rear compartment mat to bolt in floor.
